SUNNEN LAKE DAM  
WASHINGTON COUNTY, MISSOURI  
MISSOURI INVENTORY NO. 30111

PHASE I INSPECTION REPORT  
NATIONAL DAM SAFETY PROGRAM

Name of Dam	Sunnen Lake
State Located	Missouri
County Located	Washington County
Stream	Fourche Renault
Date of Inspection	25 August 1978

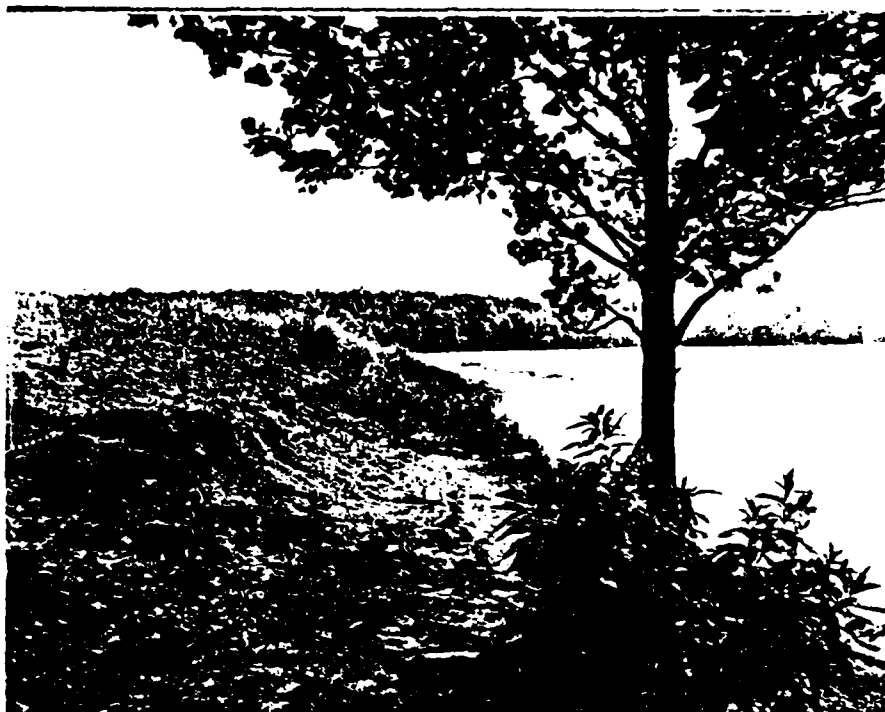
11 Benching in Upstream Slope

(3) The upstream face of the dam has no riprap or other wave protection of any kind. Wave action has eroded a bench (vertical face above a horizontal face) as much as 5 feet high along the entire dam. Wave action could be expected to be a problem at this lake because of its long narrow shape and north-south orientation with the dam at the north end. The dam's wide crown and relatively high freeboard has prevented wave erosion to date from being a serious safety threat.

(1) Several items are deficient which should be corrected. No erosion protection is present on the upstream face of the embankment and wave action has caused benching along the length of the embankment. Brush and small trees are growing on the embankment. Horse traffic on the embankment has removed grass in localized areas. Voids under the spillway apron could lead to undermining. The outlet works is presently inoperable.

c. Provide adequate erosion protection such as riprap on the upstream face of the dam. Repair benching of the embankment.
